# **MATERIALS INFORMATION HANDOUT**

**Contract Number**  
**06-459104**  
**(Project ID Number 0600020149)**

**06-KER-119**  
**PM 0.0/4.3**

**Cold In-Place Recycling**  
**Hot Mix Asphalt**

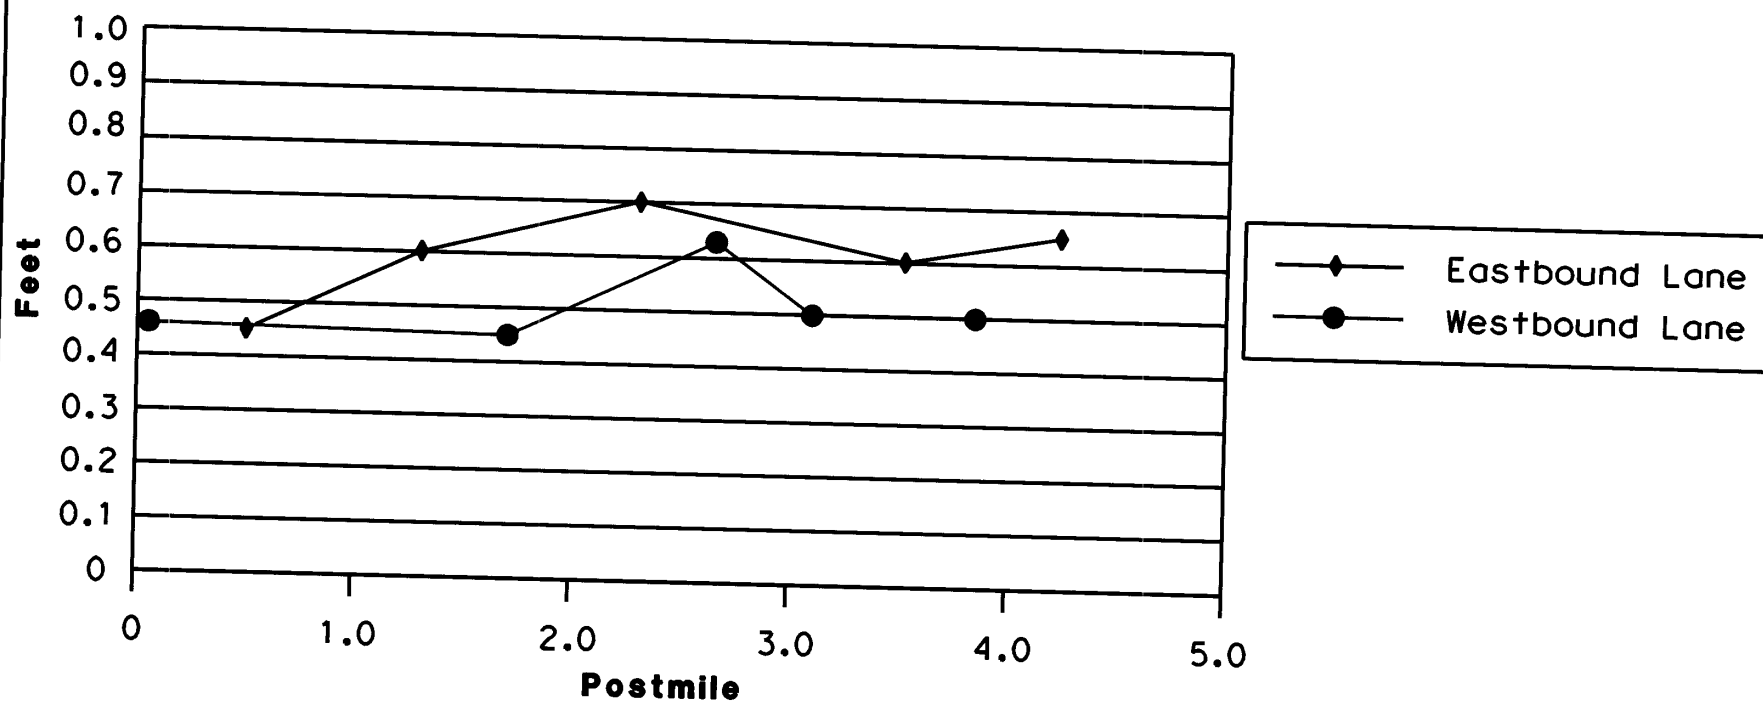
**Ker-119 AC Thickness**

The general structural section, from the bottom up, is native material, and hot mix asphalt. Cores indicated a depth of hot mix asphalt that ranged from 0.45' to over 0.70'. Core samples taken were uniform in appearance.
